HOWARD COUNTY HISTORIC PRESERVATION COMMISSION  
*ELlicott CITY HISTORIC DISTRICT ■ LAWYERS HILL HISTORIC DISTRICT*  
3430 Court House Drive ■ Ellicott City, Maryland 21043

## April Minutes

Thursday, April 6, 2017; 7:00 p.m.

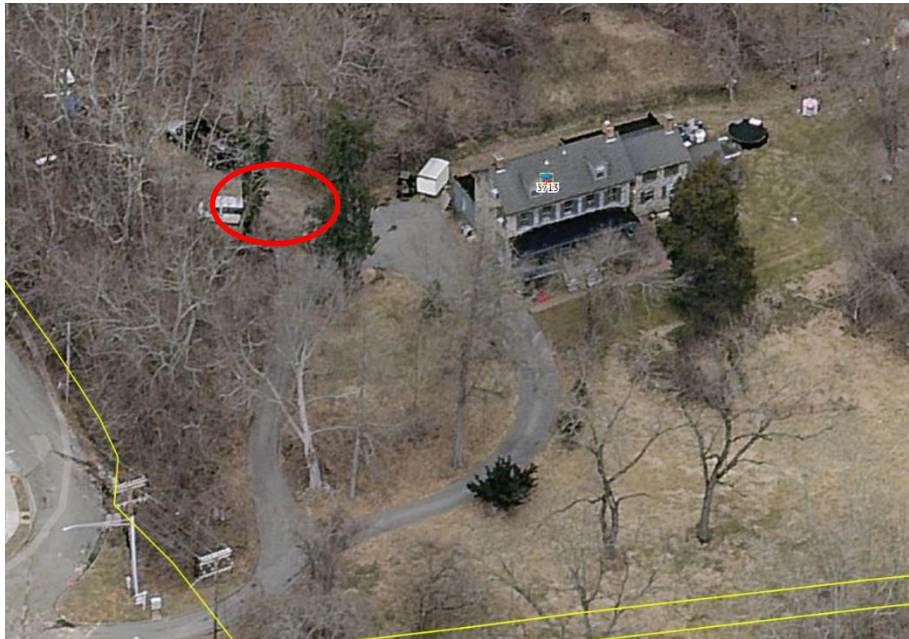
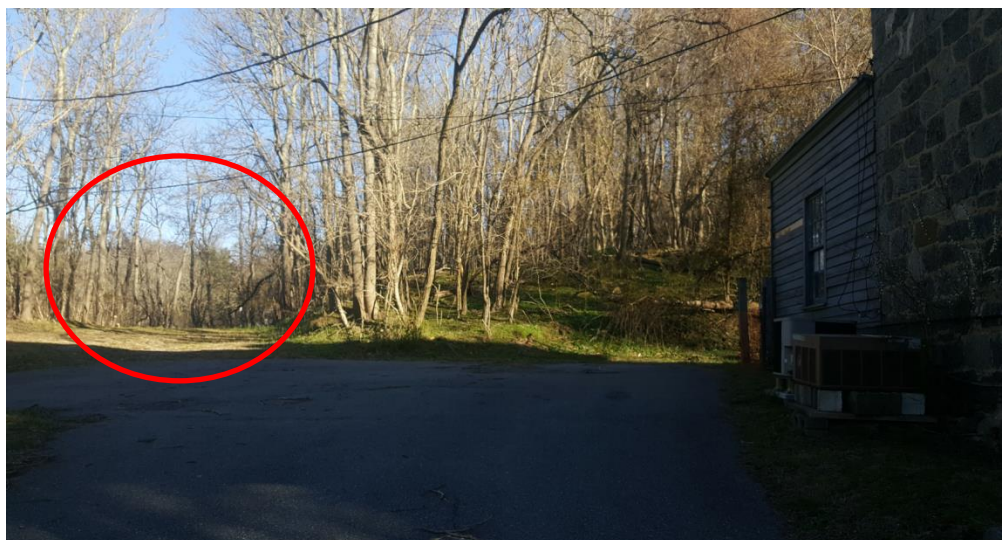
Figure 1 - Proposed location of shed

**Staff Comments:** The shed will be located behind the house in a cleared, gravel area. Upon entering the driveway, the view will continue to be of the main historic house and the shed will not be visible until one is at the top of the driveway, next to the historic house. There are several trees within the circular driveway, as well as the grade change, that makes the view of the shed minimally visible at the bottom of the driveway.

The location of the shed complies with Chapter 7 recommendations, “If allowed by the size and shape of the property, place new outbuildings to the side or rear of the main building, separated from the main building by a substantial setback” and “Do not place a new outbuilding where it blocks or obscures view of a historic building. Do not attach a new outbuilding to the principal building.” The shed will be placed to the side and rear of the historic building with a substantial setback across the driveway, as recommended. The proposed location is the only practical location for the placement of the shed that complies with the recommendations in the Guidelines. There is only a narrow strip of land behind the historic house that is graded and then the slope drastically increases.

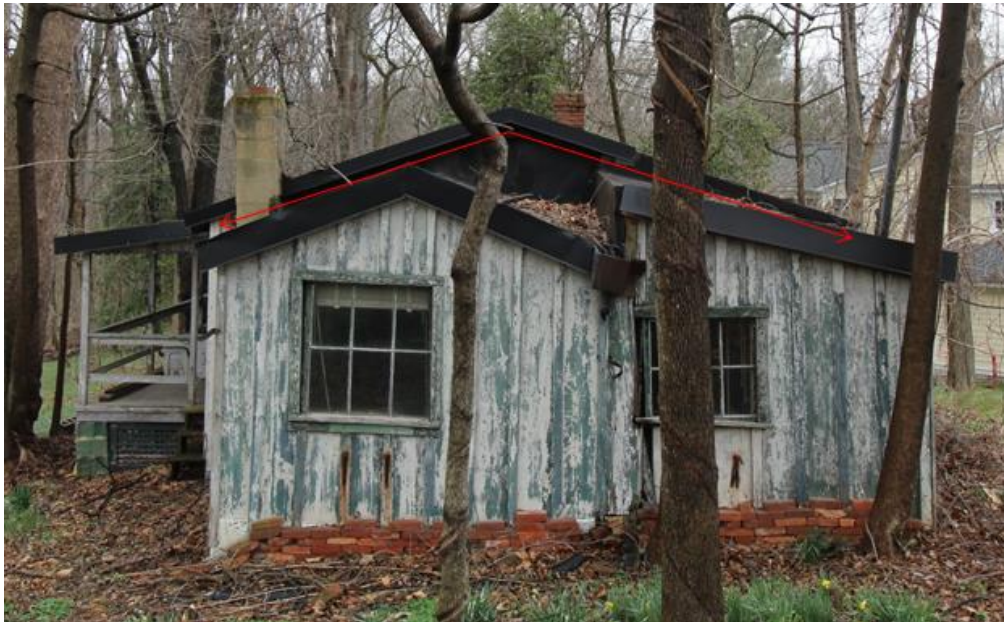
**Figure 15 - Roof**

Staff has requested construction drawings that show the proposed alterations to the pitch of the roof. The Applicant is working to get construction drawings by the meeting date, but has provided additional photos of the roof that show where the cricket will be altered to form a lower gabled pitched roof.

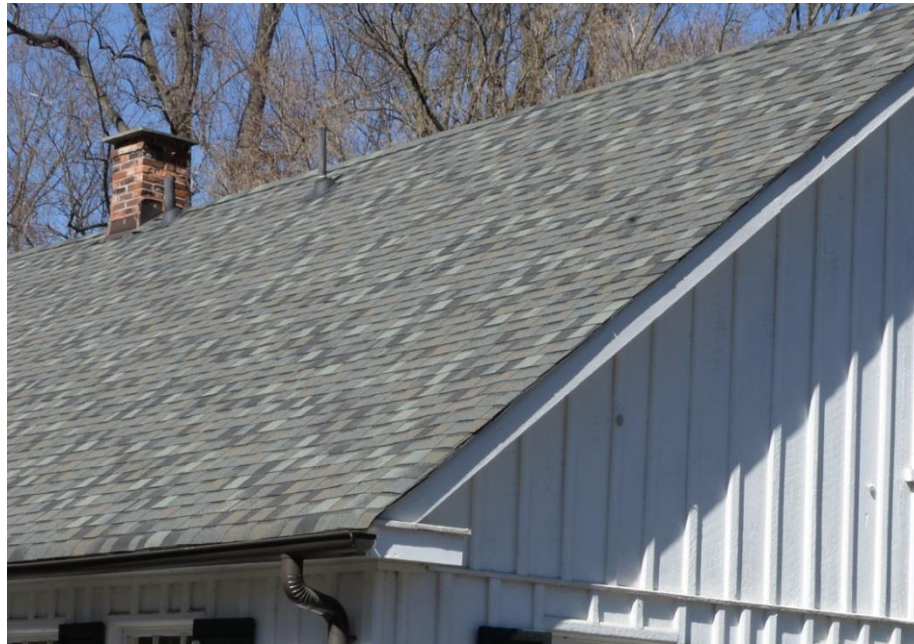
Figure 17 - Roof on main house

The proposed asphalt shingles comply with the Guidelines, “replace historic roofing with asphalt shingles or other modern materials only if historically accurate materials cannot reasonably be used. Use

asphalt shingles that are flat, uniform in color and texture and of a neutral color.” The current roofing material is not historic, and the asphalt shingles will be uniform in color, as seen on the main house.

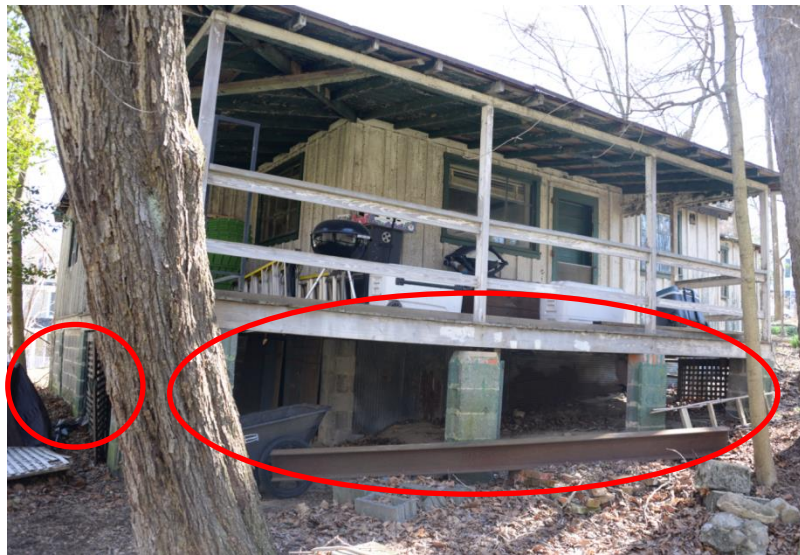
**Figure 19 - Proposed lattice**

Staff requested a photograph indicating where the lattice will be installed and the Applicant responded that the lattice will be on two sides, the front under the porch and around the side. The concrete block posts will be painted white to match the lattice, siding and trim.

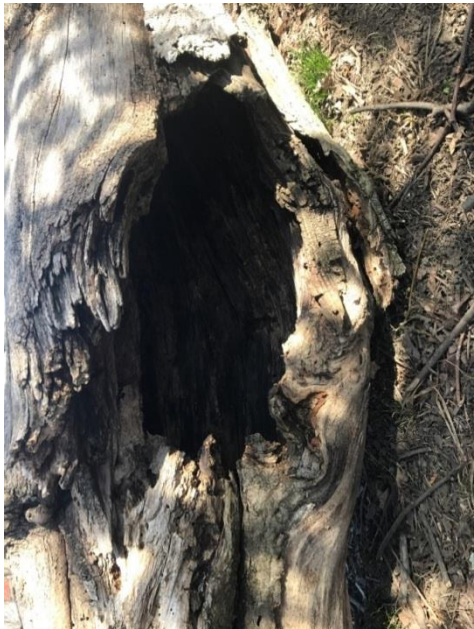
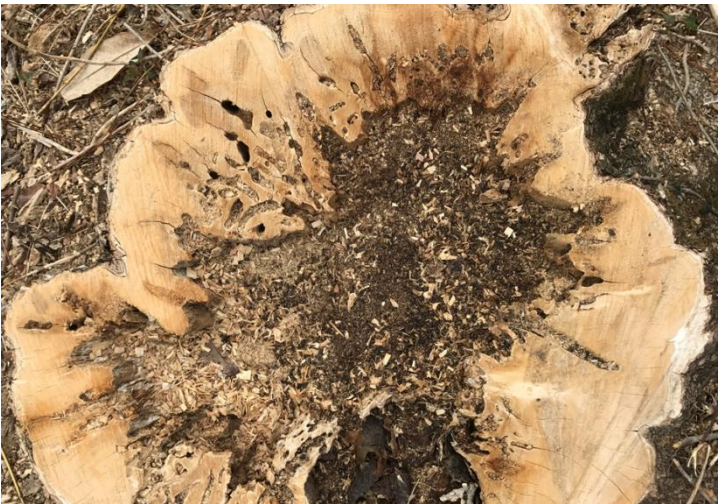
Figure 25 - Stump of tree removed

- 3) Restored the front retaining wall on the property using stone that was original to the wall and property. There was a Paulownia tree and other junk trees with thorns that were damaging the wall and had to be removed. These trees were also growing into the powerlines and were removed by BGE. This work should have been approved.
- 4) Removed a Norway Maple tree in February 2017 without approval. The Applicant stated the tree was diseased and has provided photos that show disease and damage. This work should have been approved.

Applicant stated there is not. The Applicant has provided additional photos, shown in Figures 24 and 25, that show possible disease and damage to the tree. The proposed planting of the Leland Cypress complies with Chapter 9.B recommendations, "Retain mature trees and shrubs. Provide for their replacement when necessary." While the large tree was removed, the Applicant proposes to compensate for its loss with approximately 10 Leland Cypress trees.

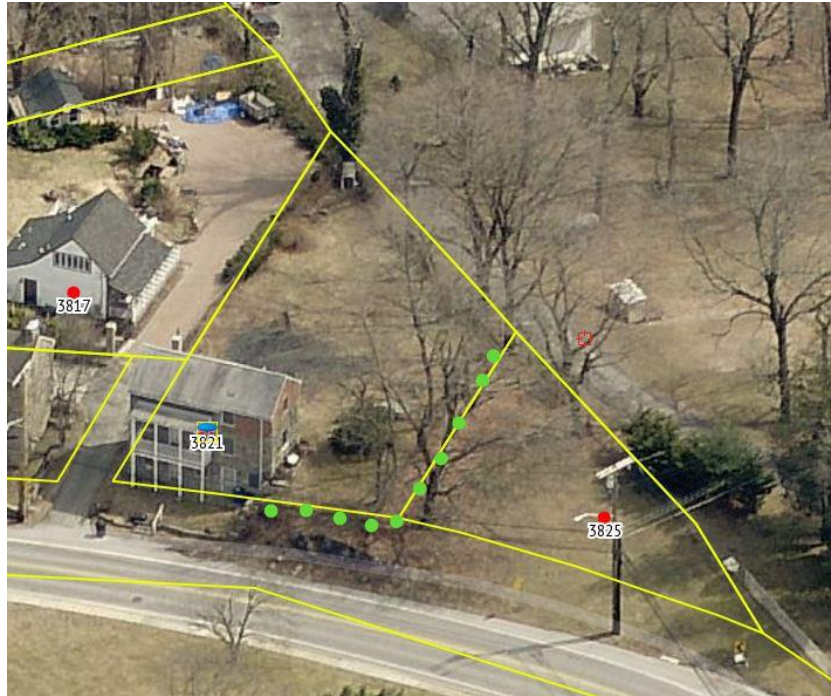
Figure 26 - Location of proposed trees

- 5) Plant approximately 10 Leland Cypress trees along the front and right side of the retaining wall, bordering the property lines of 3821 and 3825 Old Columbia Pike (as shown in aerial below). The planting of trees does not require approval, but the removal of the previously existing trees did require approval. This item is being included to follow up on the issue of the removal.

**Staff Recommendation:** Staff recommends Approval of the new tree plantings. Staff recommends Approval of the side walkway, retaining wall and retroactive approval of the wrought iron railing. Staff recommends Approval of the hardscaping walkway and patio and chimney/fireplace drawing.

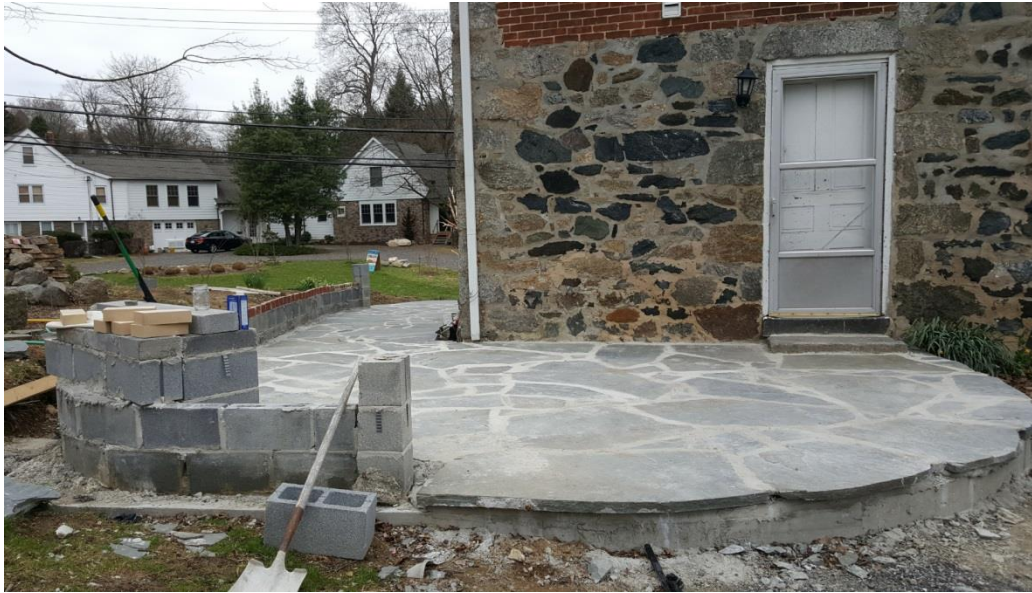
Figure 28 - Existing conditions

block and rebar with stone facing laid at 8". Retaining wall backside to fire pit will be graded to top of the wall and stone is laid on back side, on exposed driveway side stone is laid at 8". Wall ties are set every 2' in height."

Mr. Reich asked if all of the walls will be faced with the same stone as the house. Mr. Anderson said all the stone facing will be the same as the stone on the house and the front retaining wall. The stones were all sourced from Mr. Anderson's property. Mr. Anderson said the fireplace and the walkway wall will also be faced with the same stone. Mr. Reich asked for the dimensions of the fireplace. Mr. Anderson said the fireplace will be about two feet deep. Mr. Anderson said he will take the block already there then put the stone on top with a 24-inch deep firebox with foundation outside from the backside of the wall to support the stone. Mr. Anderson said there is a foundation wall that goes out further than the block but not more than the wall that curves around the retaining wall. Mr. Anderson said all the block work is done except the face of the fireplace, but first the fireplace will need to be built up more. Mr. Anderson said Figure 28 showed the back of the fireplace.

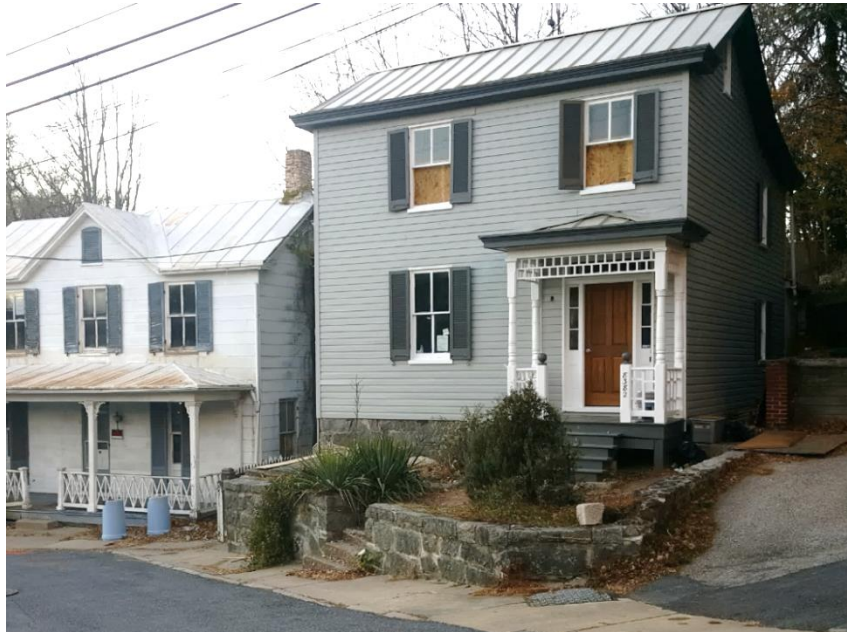
Figure 39 - Front of house

- 1) Power wash the metal roof, prime the surface with a galvanized metal primer and then paint existing light gray metal roof a new color, Benjamin Moore Black Berry, which is black.

**Staff Comments:** Chapter 6.E of the Guidelines explain that “historic roofing materials include wood shingles, metal and slate...To retain the district’s historic character, every effort should be made to repair and preserve historic wood, metal or slate roofing, particularly for roofs visible from public ways.” The Applicant proposes to keep the historic metal roof and paint it a new color, Black Berry. The painting

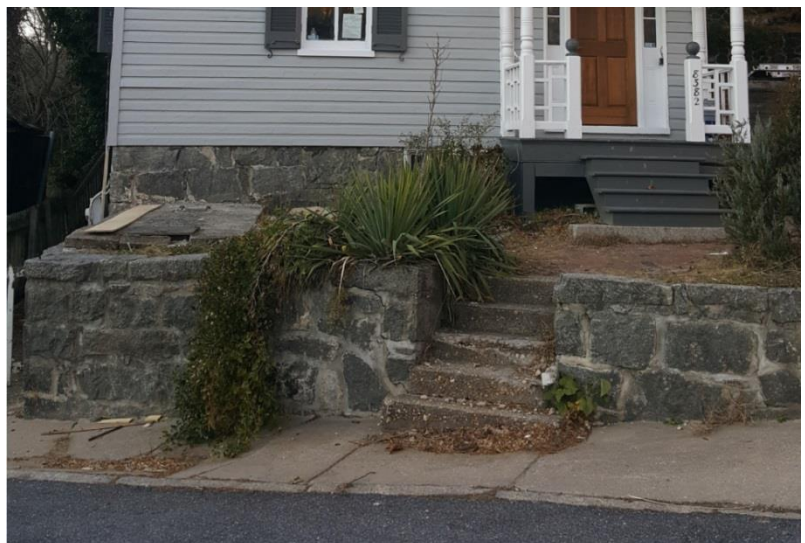
Figure 40 - Front steps and retaining wall

- 2) Remove concrete steps at front entrance and install granite steps. The brick front walkway will be reset. The front and side granite retaining walls will be repointed as needed.

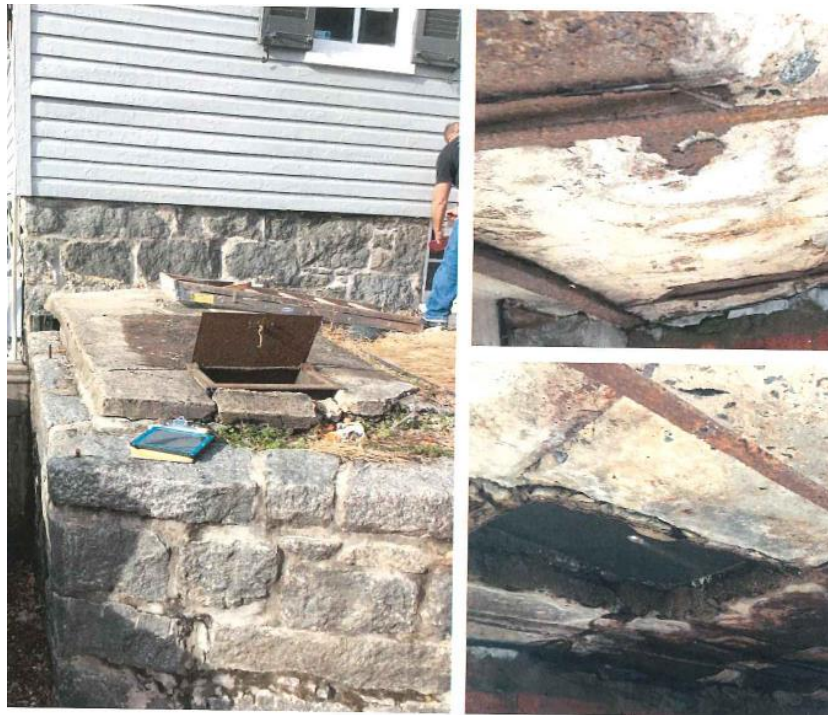
Figure 41 - Concrete slab

- 3) Remove the existing broken concrete slab above the basement entrance and install a new concrete slab. The existing slab is cracked and in danger of collapse. This would be an in-kind repair and considered Routine Maintenance.

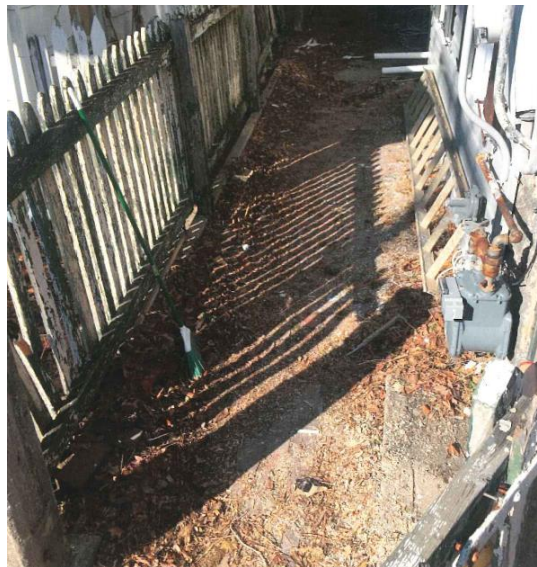
Figure 42 - Brick side walkway

- 4) There is existing brick paving on the south west side of the house. The Applicant proposes to remove the brick, pour a concrete slab and install new brick pavers in the side walkway.

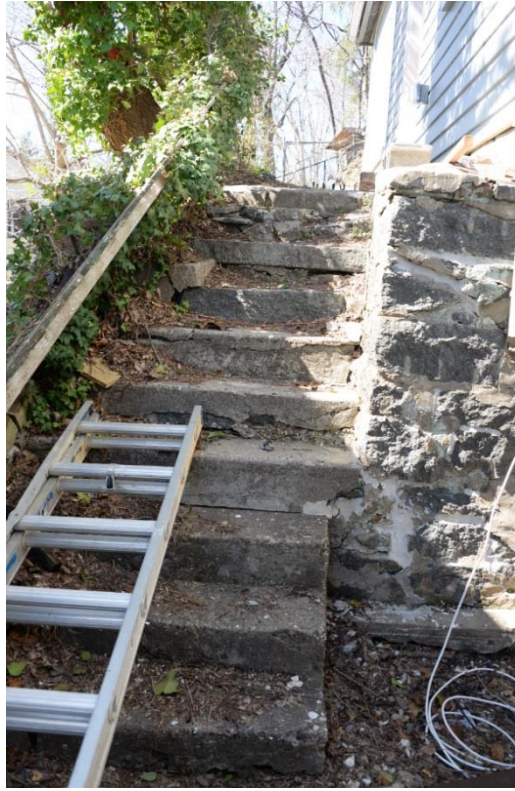
- 5) The steps in the side yard are a mix of concrete and granite. Remove damaged and uneven concrete steps in the side yard (south west side of house), repair the existing granite steps and replace the concrete steps with new granite.

**Figure 43 – Concrete and granite stairs to be all granite**

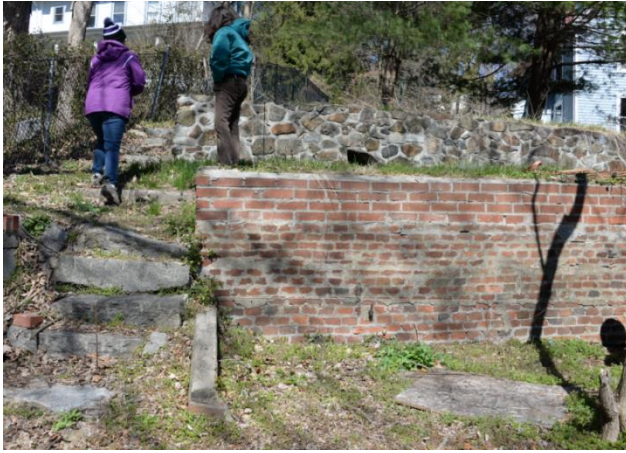
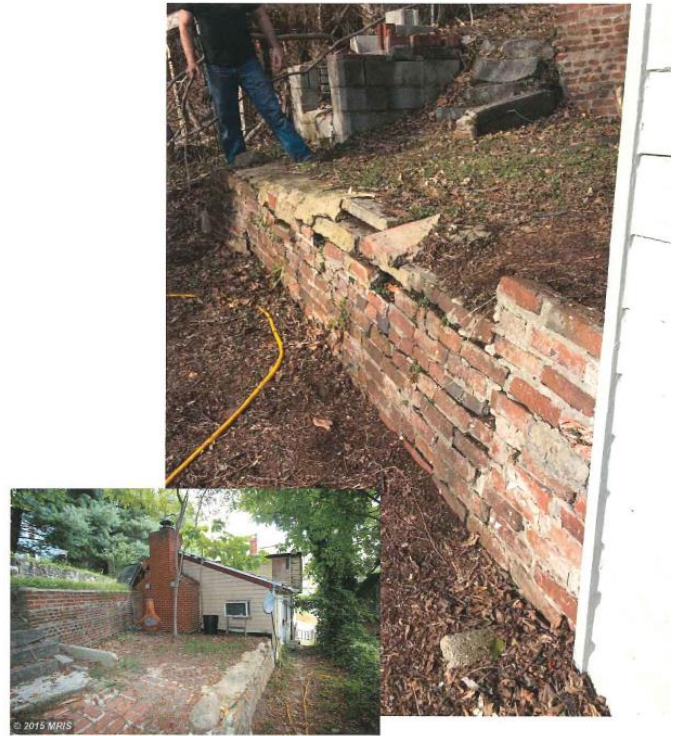
Figure 45 - Rear retaining walls

- 7) Repair and repoint the small collapsing brick retaining wall in the back yard and replace bricks as needed.

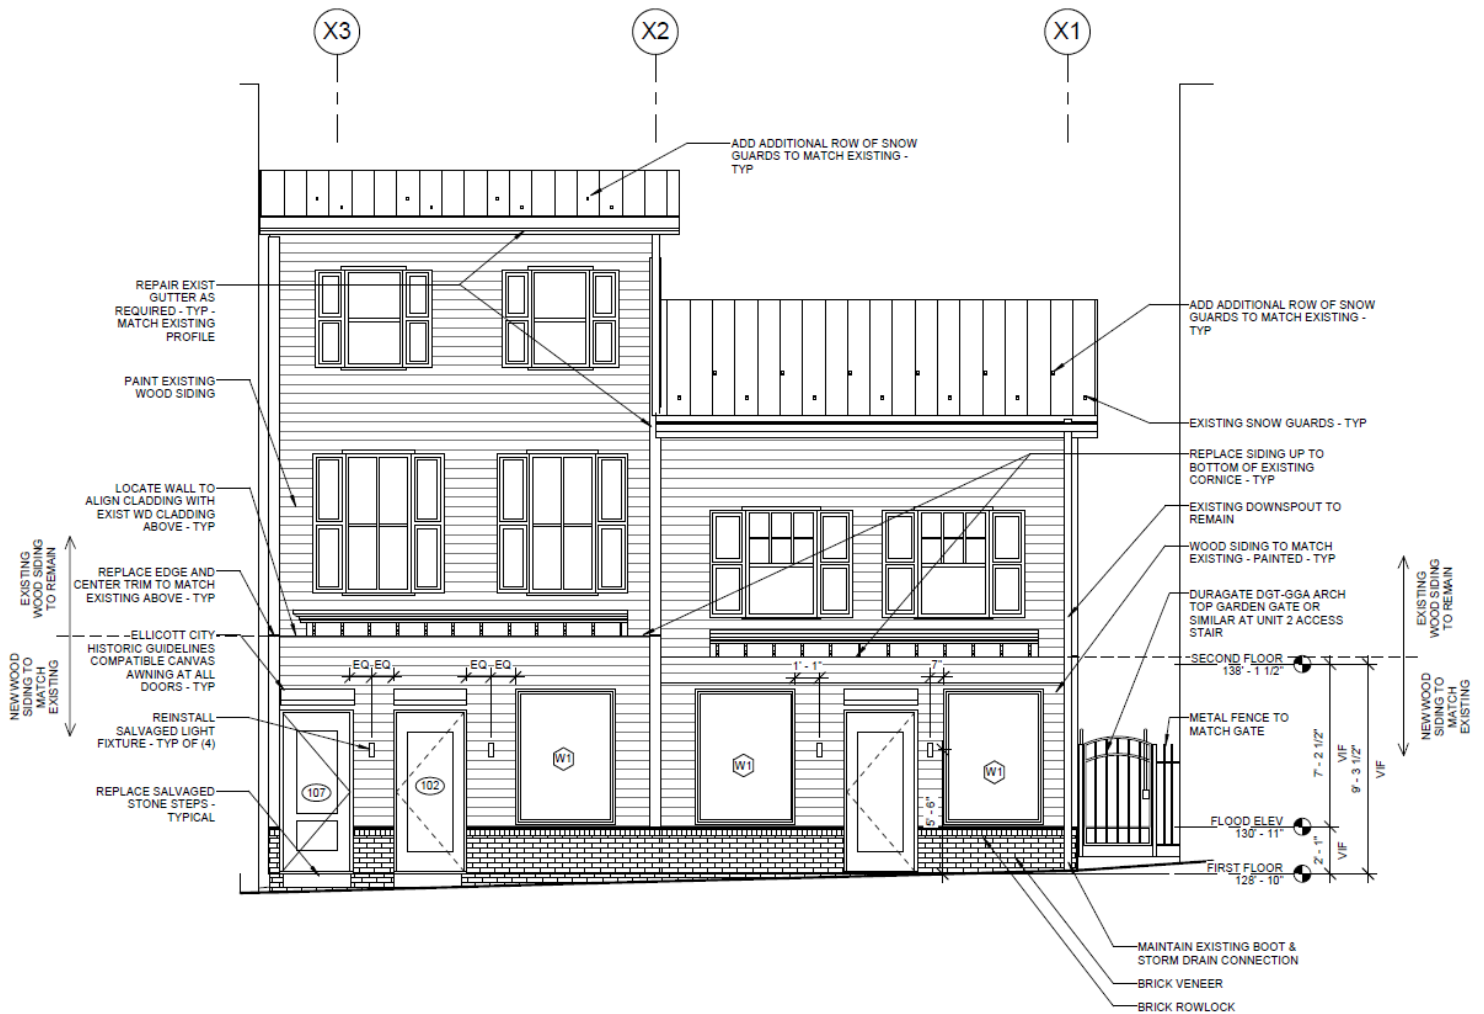
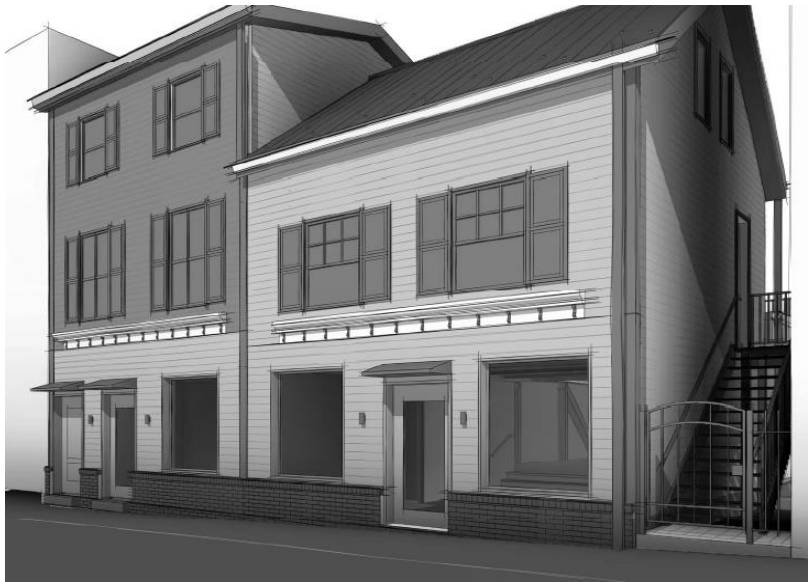
Figure 53 - Proposed repairs and alterations

- 10) Granite steps – Reinstall salvaged granite front steps.

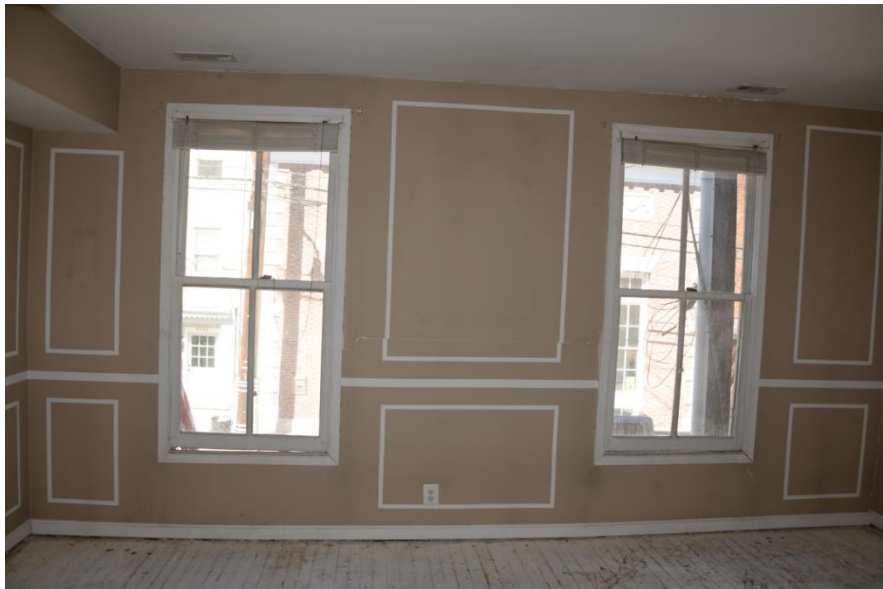
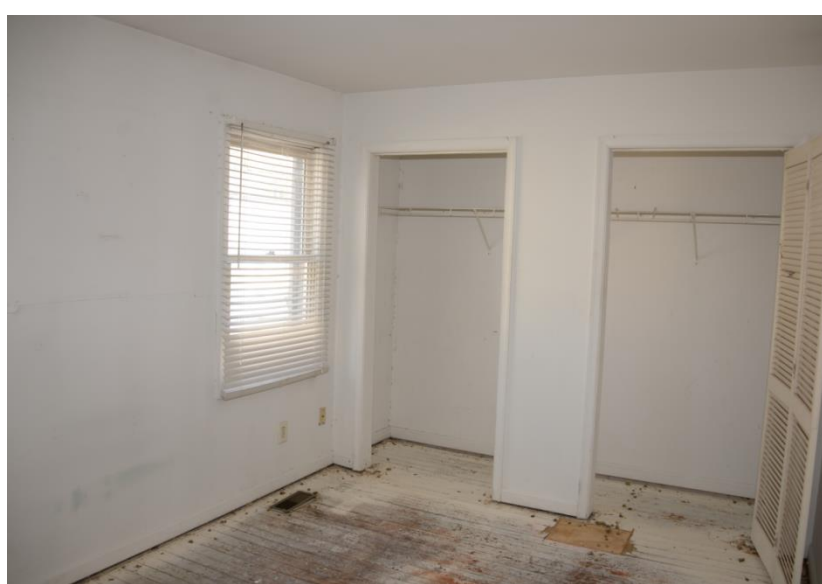
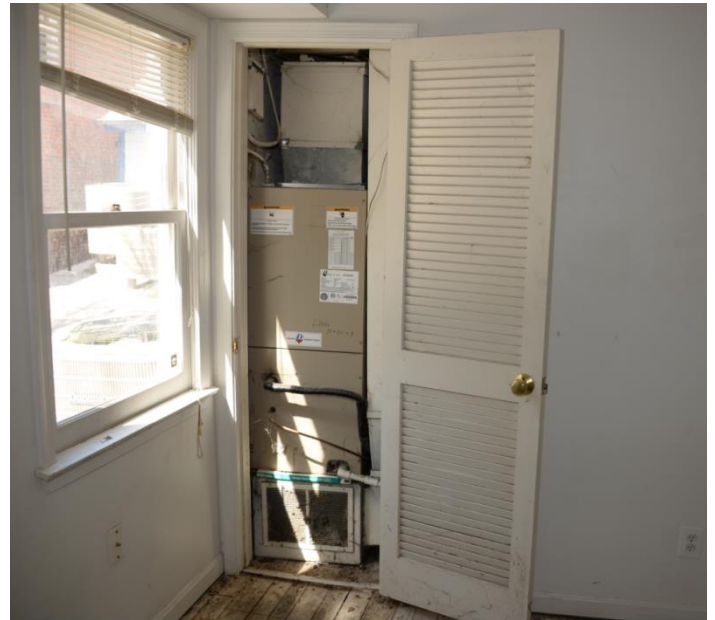
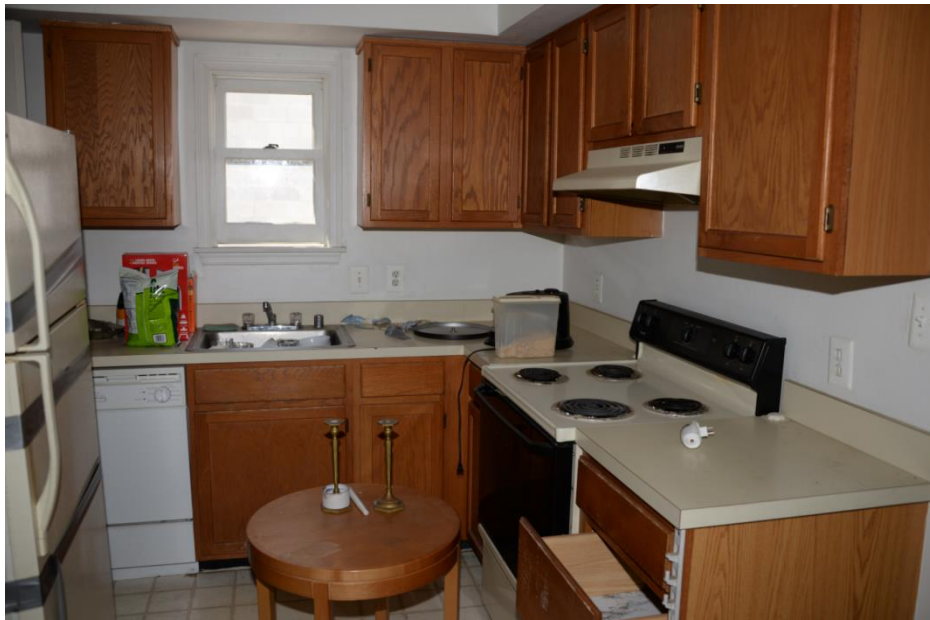
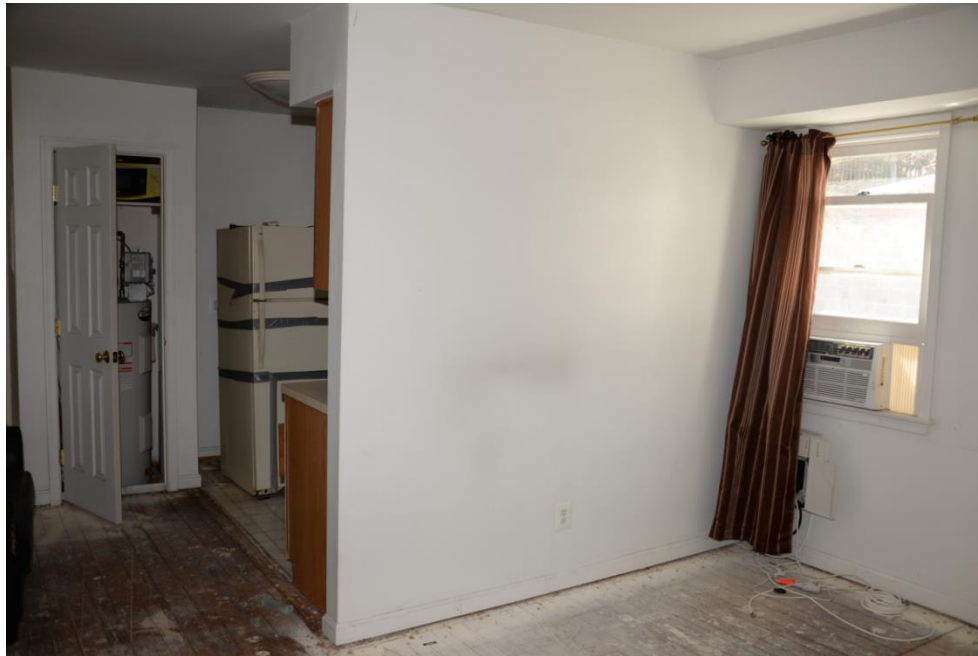
Figure 63 - Interior apartment

The upper floors were open to the elements for several weeks and the floors were sagging due to the first floor damage. There was no evidence of historic elements in the apartment units. The carpet was damaged and removed and will need to be replaced. There is damage to drywall and trim in some areas that will need to be repaired or replaced. Similar to the first floor, the ductwork will be reconnected to the HVAC systems and the ductwork will be repaired or replaced as needed. The owners have indicated that the refrigerators are leaking and need to be replaced, but that the rest of the kitchen appliances are also being replaced at this time, although they are functional. The windows on the Main Street in the east building do not appear historic, but they are wood two over two windows. The windows appear to be slightly off kilter due to the sagging building and may require repair.
